# Waterproofing Challenge: World Trade Center *Reflecting* *Absence* Fountains

By Nick Leuci

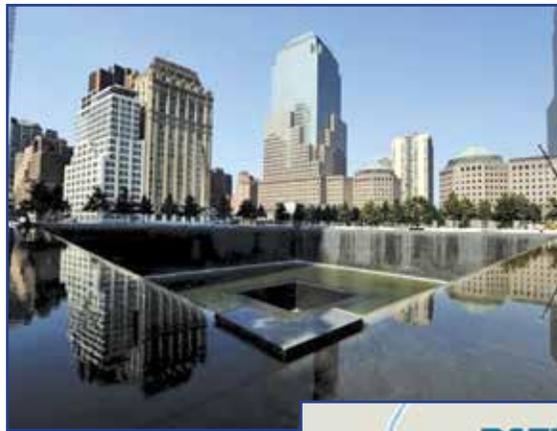
Figure 2 – Visitors' view into the pools and surrounding buildings.

The fountains would consume approximately an acre of real estate for each pool. Water cascades 30 feet down into the first stage of the pool (the upper void), and then falls another 21 feet into the center of the pool (the lower void). The fountains are surrounded by a 12-acre park that provides a serene setting. Visitors to the site are engulfed in the sound of the waterfalls as they approach the fountains (Figure 2).

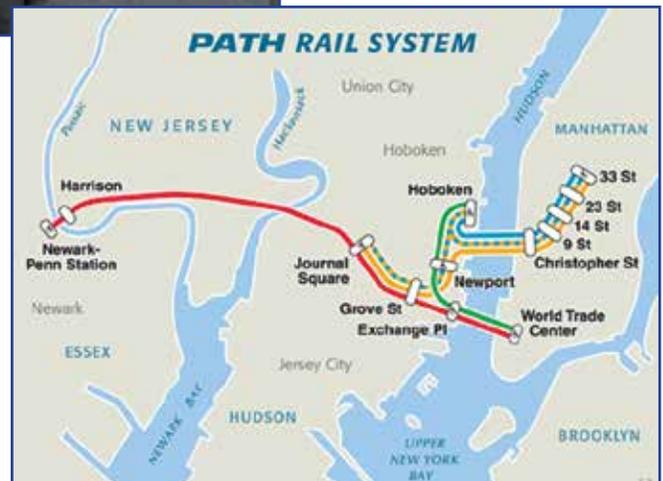
Figure 3 – The WTC is arguably the most important stop on the PATH rail system. The rails run directly below the pools, increasing the need for a high-performance system that will not leak.

There is a very limited amount of space present at the WTC site. The importance of the waterproofing becomes evident when you consider that below the pools are a subterranean museum, the Path tracks (Figure 3, the heavy rail-rapid transit trains that make up the primary link between Manhattan and neighboring New Jersey), and the physical plant for Towers 1-4. Keeping these structures free of water was an engineering feat that required high-performance materials and a team of experts that understood how to address the difficult details of the construction.

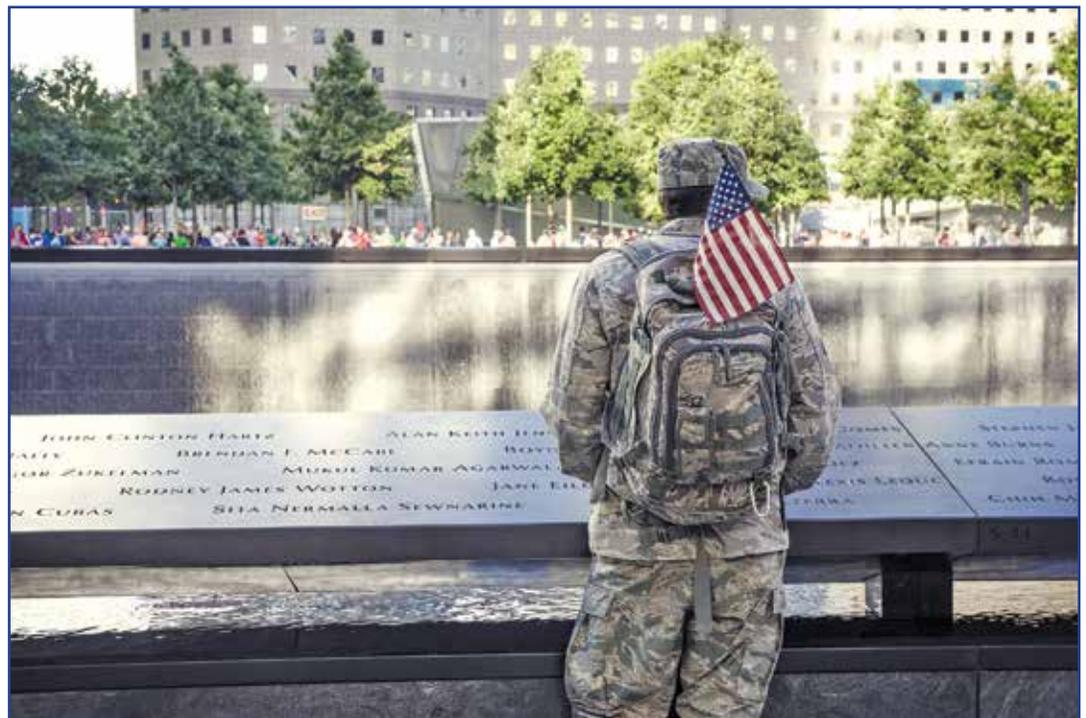
Figure 5 – Plates surround the fountain with the names of the victims. There are numerous penetrations through the waterproofing to provide the heating and cooling for the plates.

Other details—such as tie-ins to penetrations, drains, and conduit—were kept to a minimum. With the exception of the water supply pipes and drains, all penetrations in the fountains were kept above the service levels of the pools. Penetrations occur above the water level and then branch down, concealed by a nameplate parapet and stone cladding to where they are needed within the pools. Where penetrations did occur below the water level, the trowel grade was used to form a self-terminating seal to pre-

vent water intrusion in these areas (Figures 5 and 6).
